# Service Instruction

# PRIMUS

**Code No.** : H951 525823  
**Date** : Nov. 2007  
**Subject** : Instructions for improved functionality of the doorlock  
**Valid for** : **Freestanding washer extractors 16 – 22kg / 35 – 50lb**  
16kg – 35lb from serial No. "01665"  
22kg – 50lb all  
MFS35xxFTS : all  
MFS50PNFVS : all

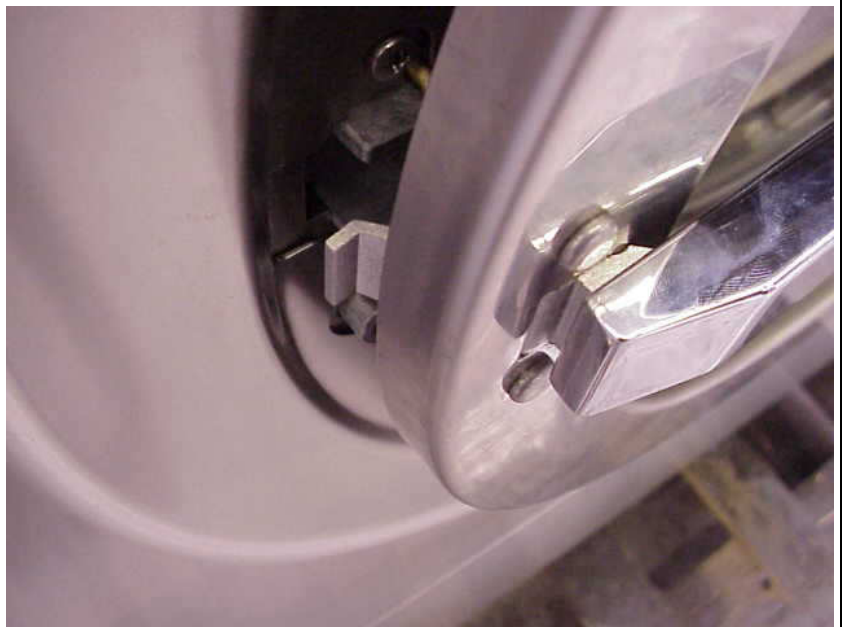
19) Close the handle while the door is in an open position.

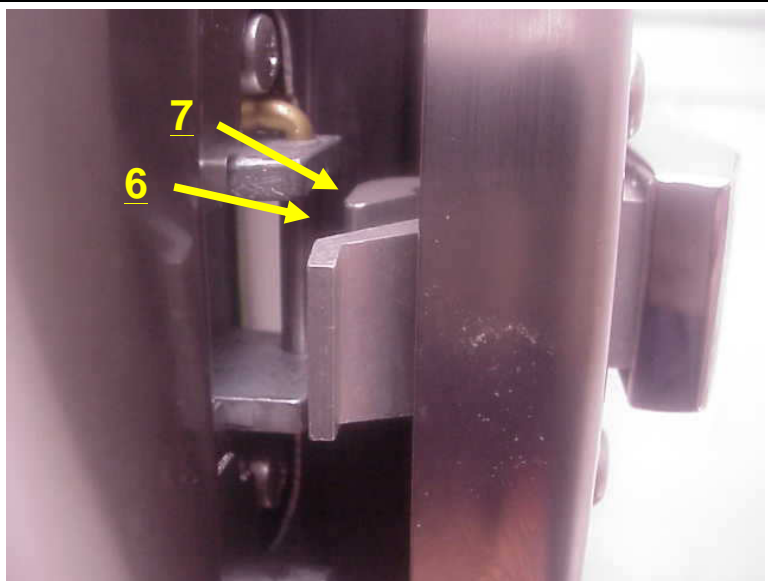
**Situation : Normal gasket pressure**

### 23.c Normal gasket pressure

Door latch is pushed back, the door pressure at hinge side is good

Distance between the bottom of the latch "7" and the stainless steel roller "6" of the doorlock is :

**10 – 15 mm (0.4" - 0.6")**

**Proceed with "Chapter 7"**

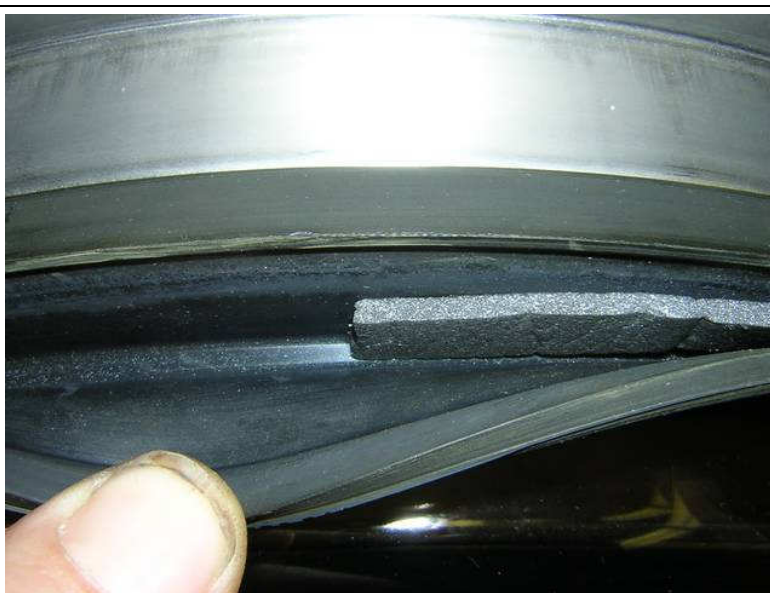
- 24) Due to some plastic deformation of the door gasket, some sealing pressure can be lost. Therefore part # 284.000.012.003 : foam rubber strip of 1 m with thickness 3 mm has to be placed in the groove of the door gasket.

Clean the groove in the door gasket and make sure it is dry.

Pull the protection foil off the back of the foam rubber for a distance of 40 to 60 mm. Put the foam rubber into the groove, so it rests on the bottom, starting at the top side of the door and stick it to the side with the door glass.

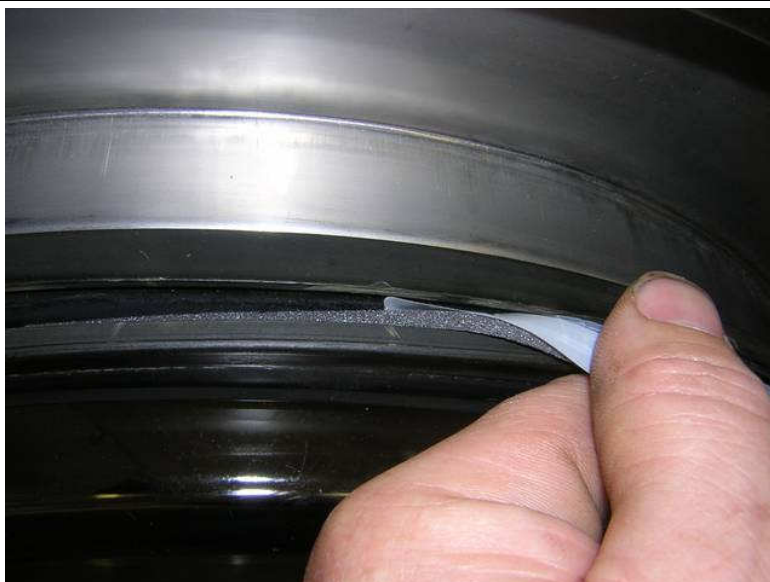
- 25) Push the foam rubber to the bottom of the groove, do about 40 to 60 mm at a time and then pull off the protecting foil.

Continue with this procedure until you go completely around the door.

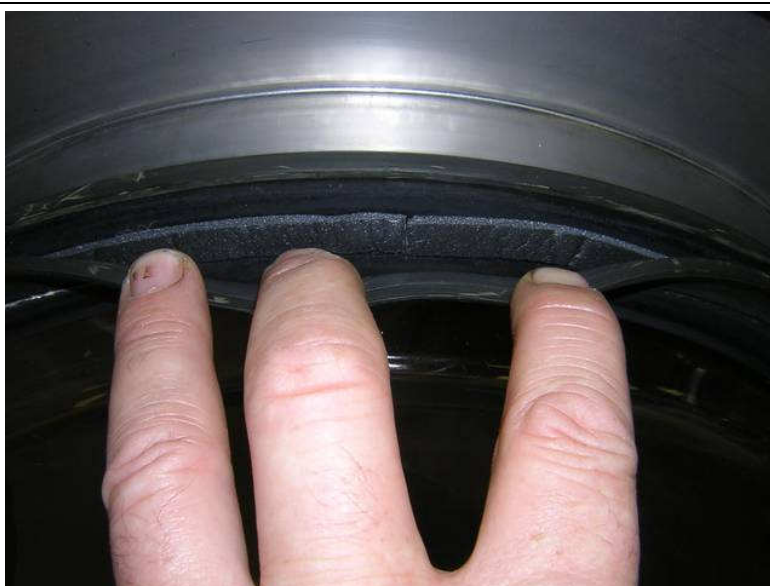
- 26) As the circumference is nearing completion, measure the correct length of foam rubber that is needed. Do this accurately, because the foam rubber cannot be overlapped or it should not be short. The strip has to butt up.

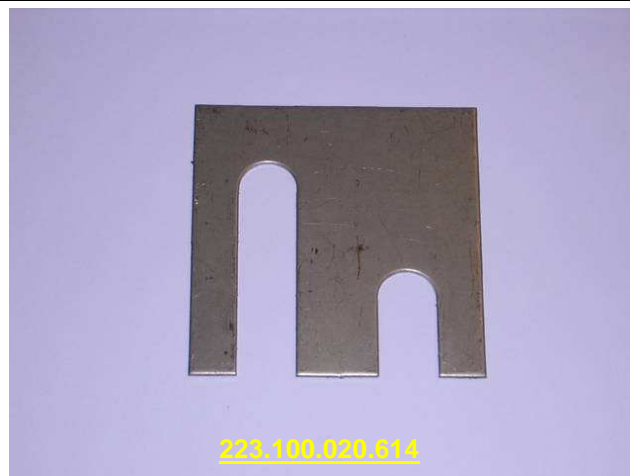
The high pressure has to be reduced by making distance between tub rim and door gasket bigger. This can be done by adding a shim between the hinge and the front side.

Shim part # 223.100.020.614.

This shim is located between the hinge and the front side.

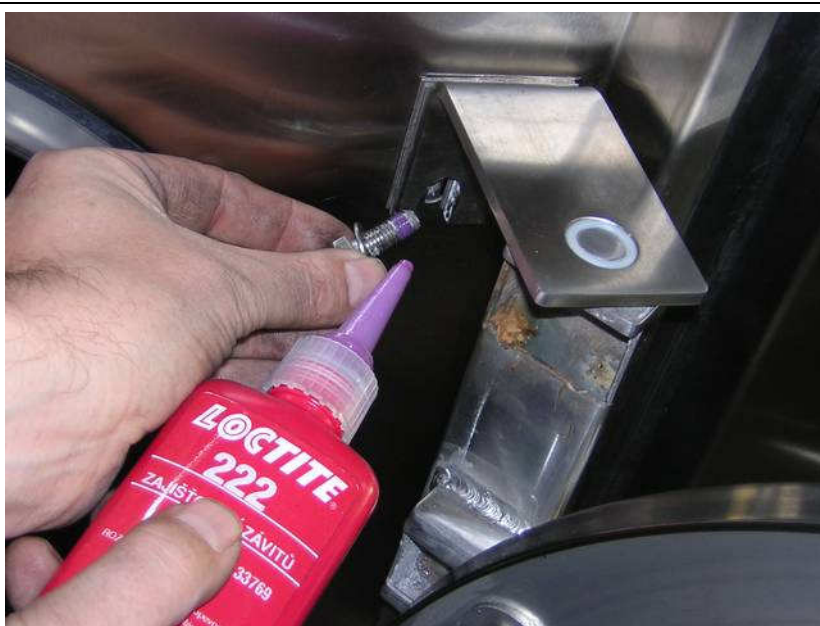
32) If no leak is detected and the door is in the correct position and properly adjusted, firmly tighten the bolts M8 of the hinge with a torque of 18.5 ft. lbs (25Nm).

Use a normal screw lock before fastening the bolts M8, for example loctite 222 or similar. To use such Loctite or similar, it is **NECESSARY** to remove the bolt **FIRST** before applying the standard screw lock. Then tighten to the correct torque. Do one bolt at the time, so that the door doesn't change position, if necessary support the door. After tightening up with the required torque, again verify the door position. See "Chapter 2"

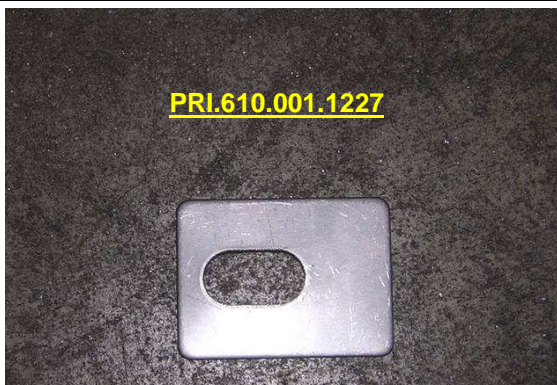
35) The high pressure has to be reduced by making distance between tub front and door gasket bigger. This can be done by adding a shim (part # PRI.610.001.122) between the doorlock and fixation point tub side.

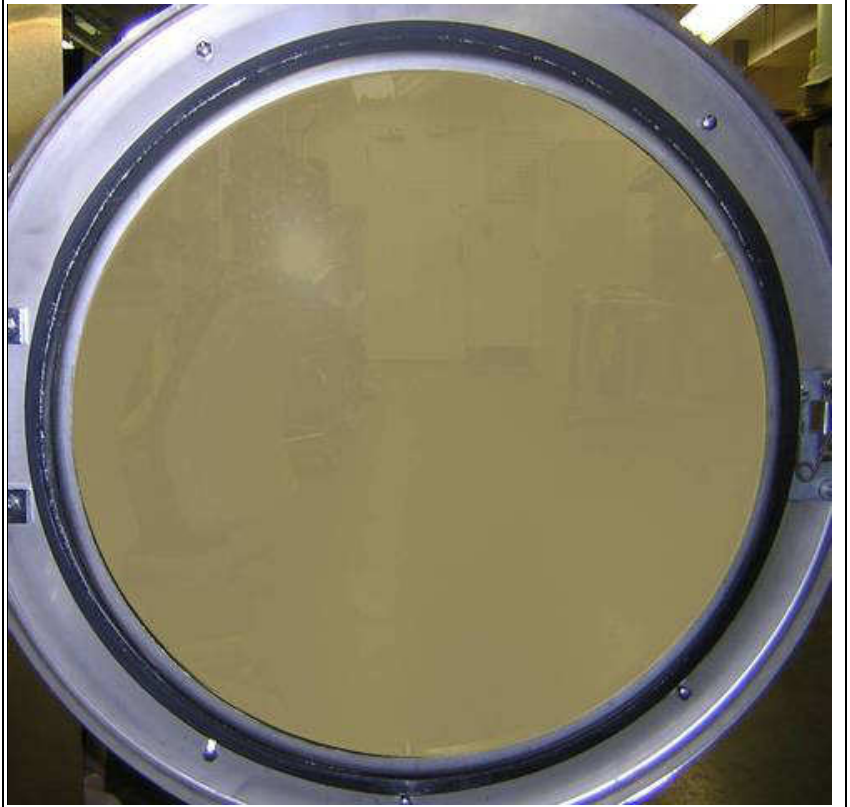
46) Repeat from item # 44 on.

Verify that a chalk transfer occurs over the total seal circle.

After tightening up, please verify again the door position. See "Chapter 2" and "Chapter 3" item # 23.c,.
